Restoration of a
1921
Westinghouse
model RC

by
Jean Marcotte
for

SQCRA

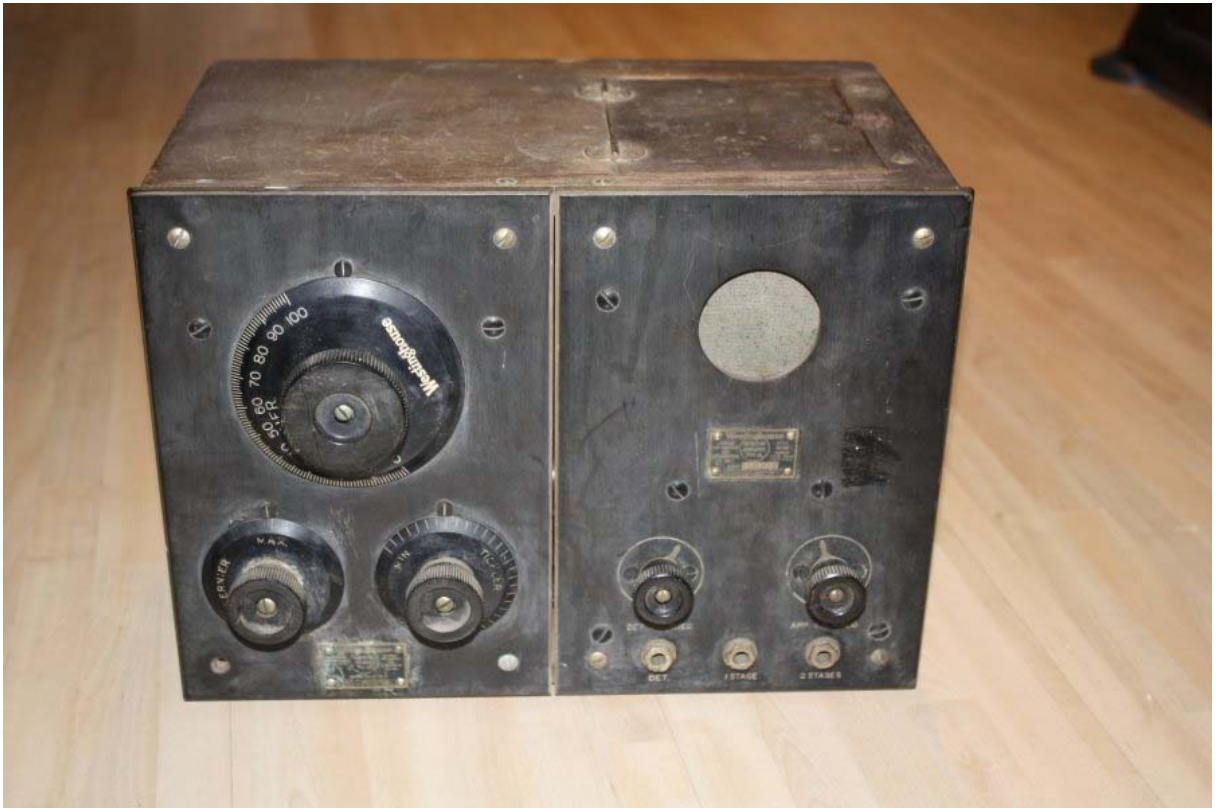
So here we are with the radio in the state I found it.

Doesn't look like a big wreck yet. The left part, the RA section is the tuner. It is a passive unit with a variometer, two variable condenser and a 31 position switch for the regeneration. By the way, all three controls are frozen.

The right part, the DA section, is a three tube unit, the detector tube and two audio amplifiers with the associated parts, the grid leak unit, a condenser, two audio transformers and two rheostats.

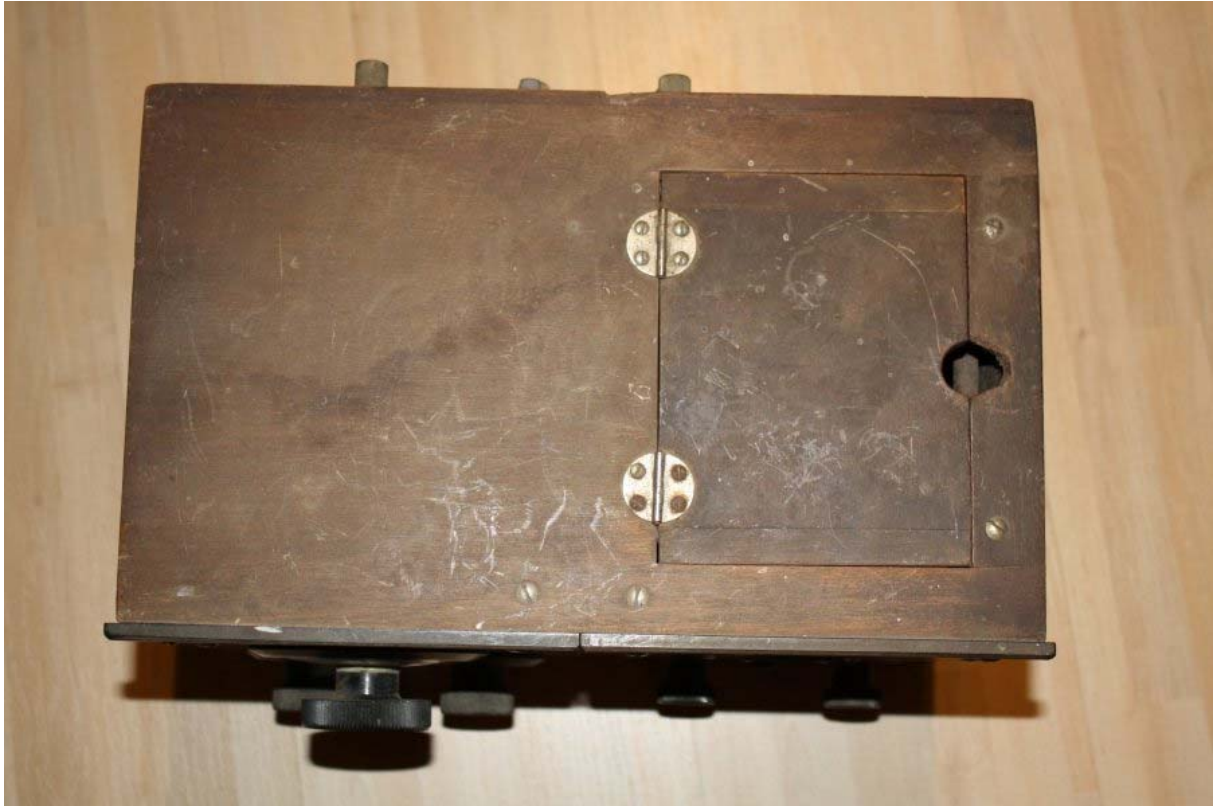
View of the top. The mice enlarged the hole to be able to enter.

The casing, although quite simple had a few issues. The hole on top wick had been enlarged by the mice, the cracks in the wood, the warping of the back and finally, Mr. Jinks' damage on one side.

I took the casing apart. A piece of the back remained glued to the top panel. I started with Mr. Jinks' damage. The scratches were deep and the crack was wide. The wood panels are made of mahogany and are 5 mm thick. The scratches were over 1 mm deep. I had three options. Replacing the panel with new wood, filling the scratches and gluing veneer or thinning the original panel by sanding it. I chose the third option because it is the easiest, keeps the look of the original panel and I can always revert to option two or one if I am not satisfied. Another benefit was collecting the dust from the belt sander and mix it with glue to create a filler for the cracks. The panel ended a little less than 4 mm and was still sturdy enough. The broken panels were glued back together and warping controlled in the process with numerous clamps. The enlarged hole was filled with my homemade filler.

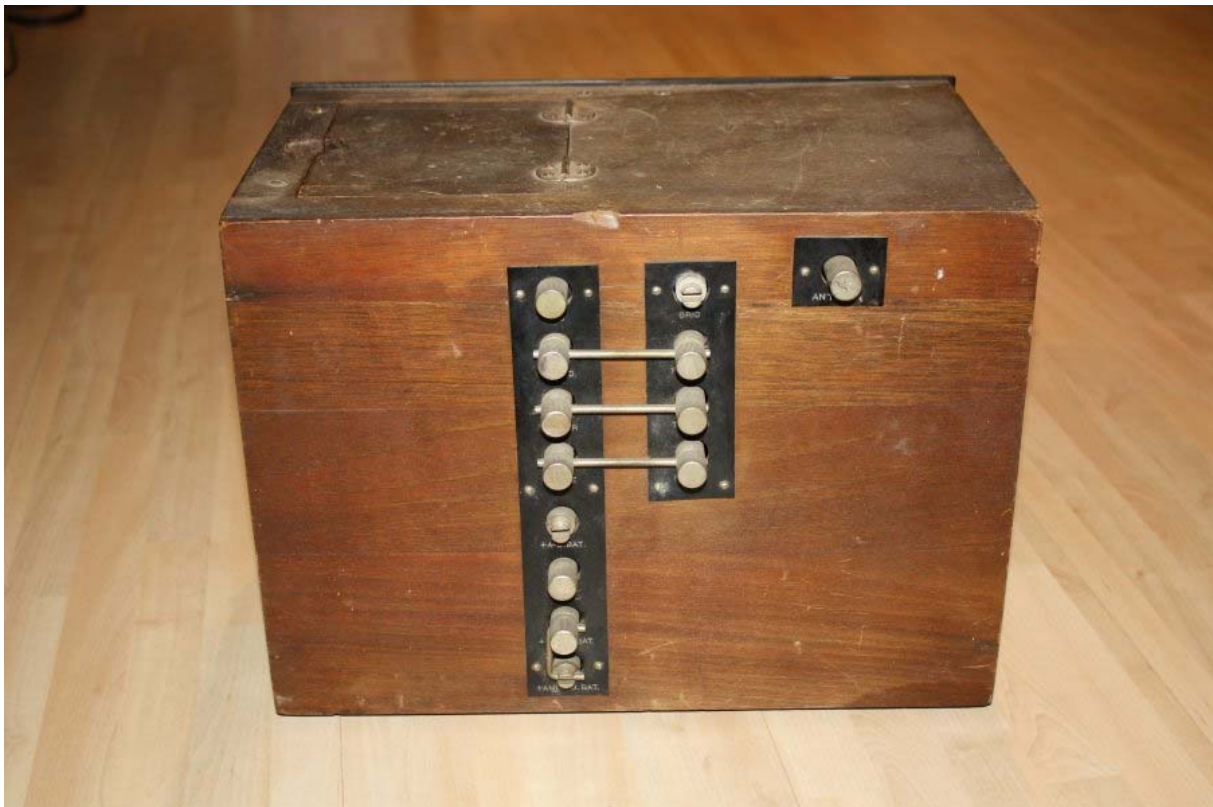
A view of the back.

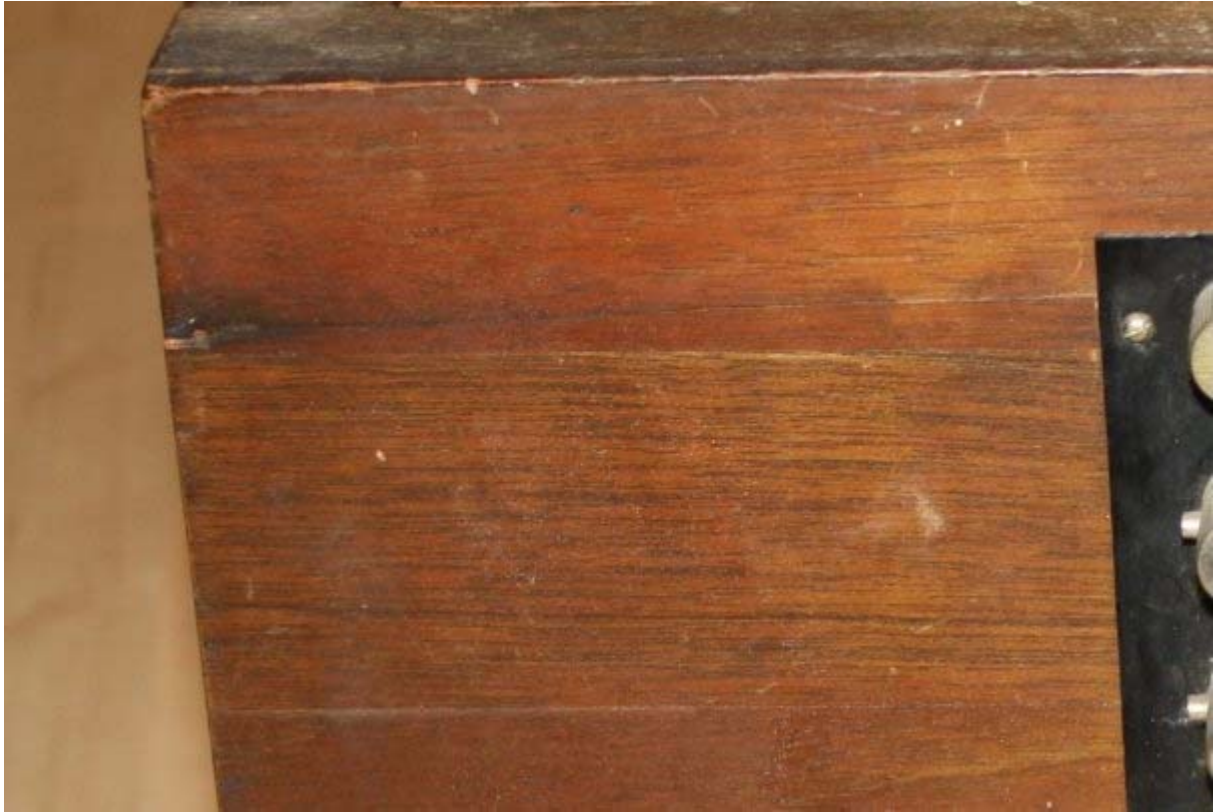
Detail of the back showing numerous cracks.

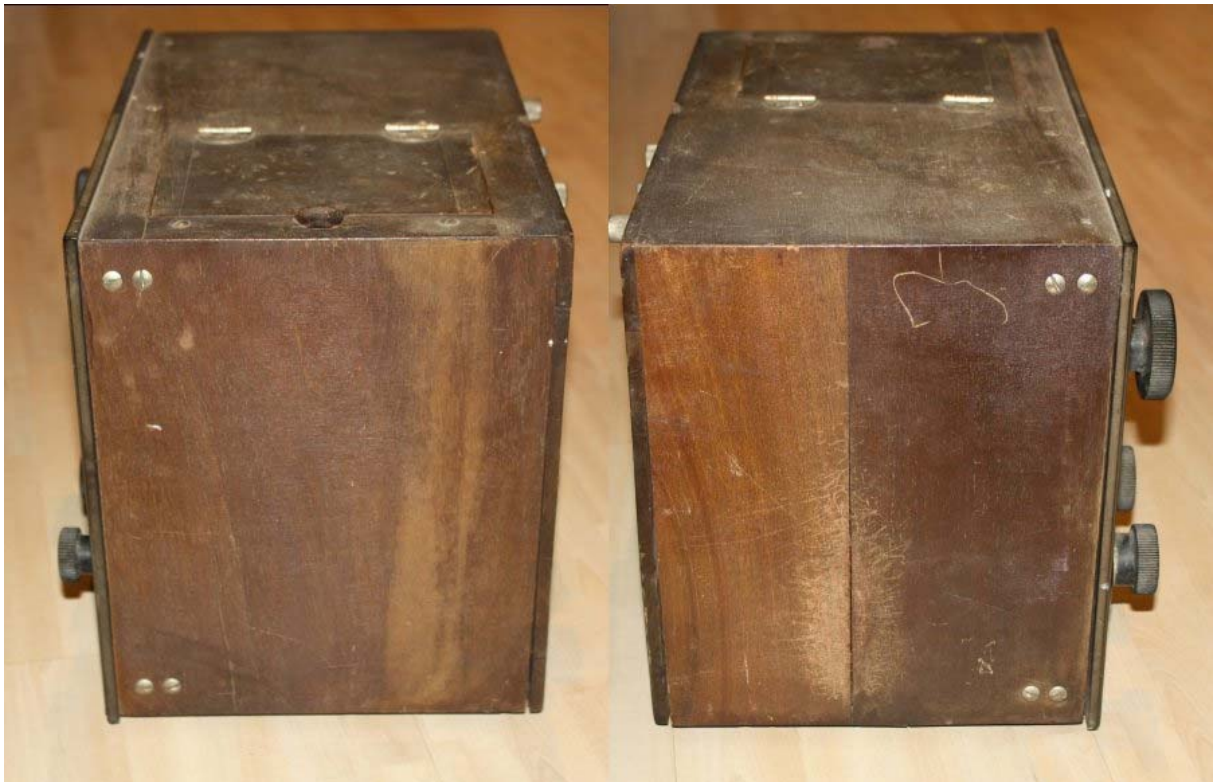
Left and right side. Cracks again and back unglued and warped.

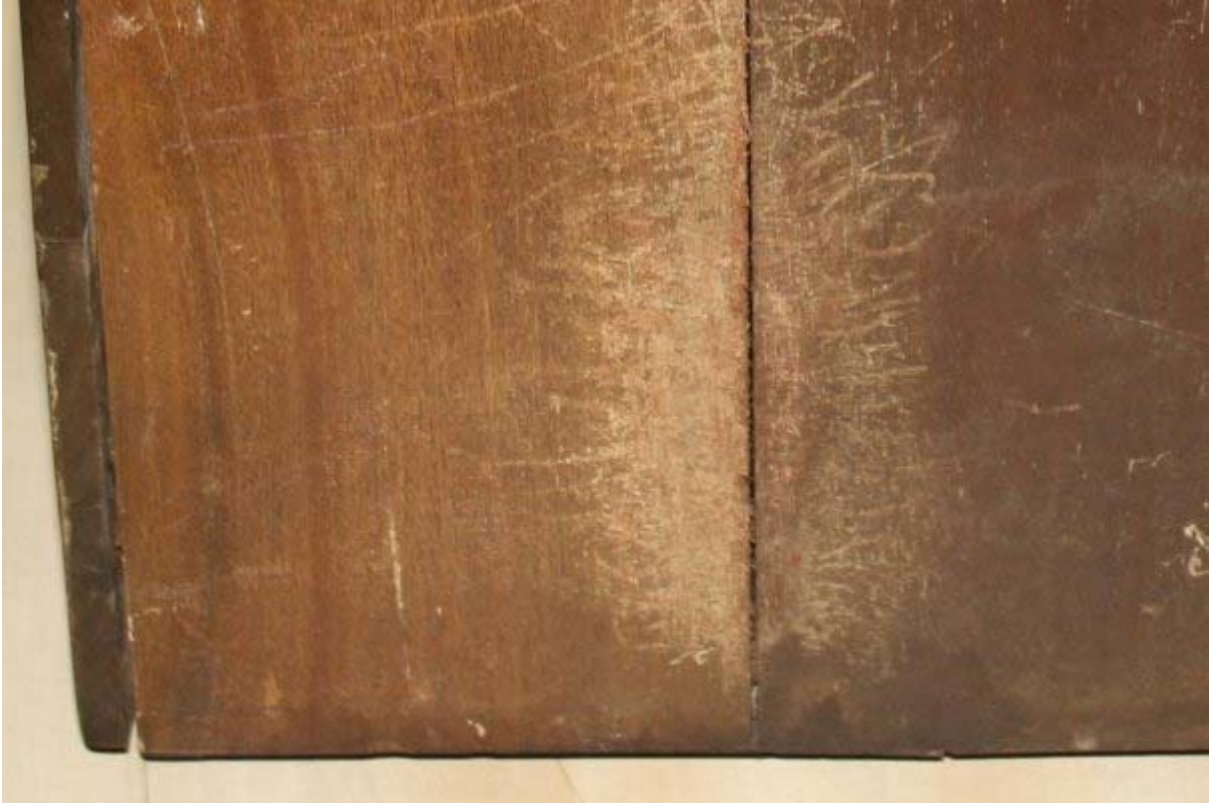
Detail from the left side showing a large crack. This is where Mr. Jinks appears. He definitely could hear and smell the mice through the crack. He tried hard to get to them by digging with his claws in the wood and caused a fairly deep recess in the wall. Unfortunately he was not smart enough to open the door on top.

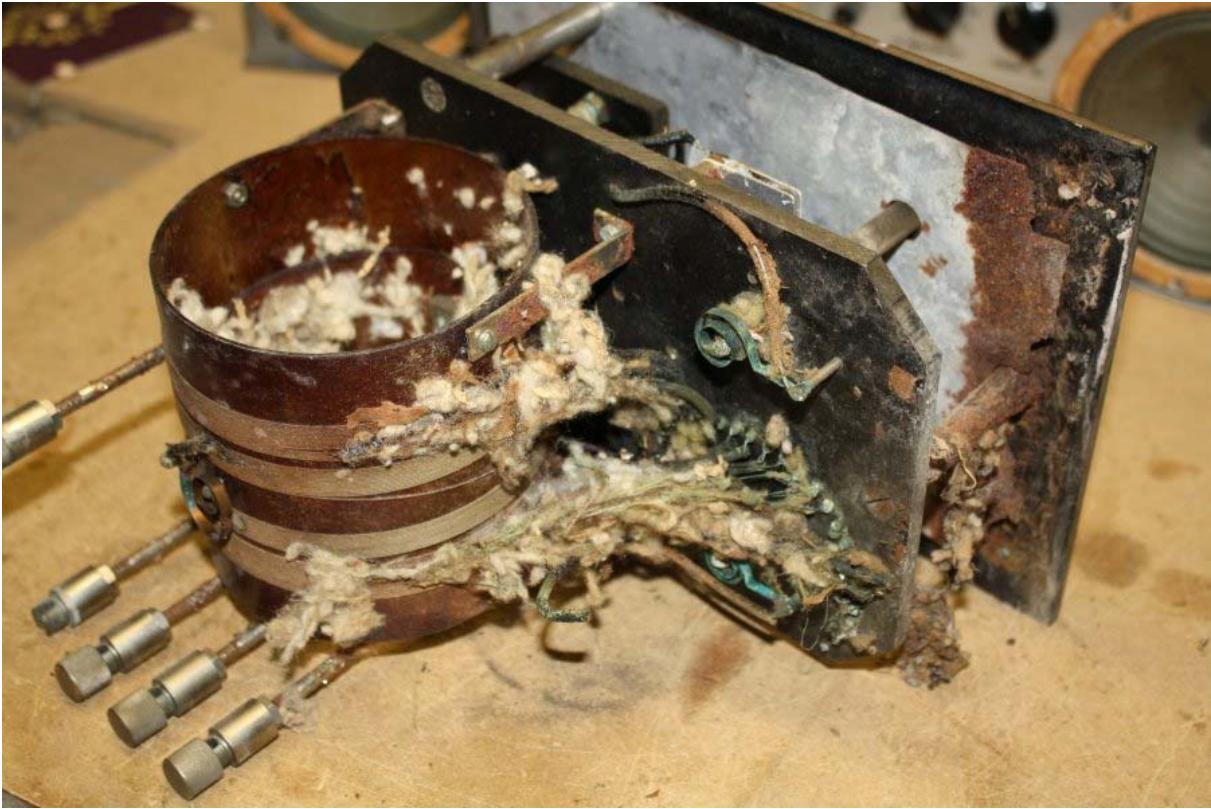
Views from the inside of the RA module.

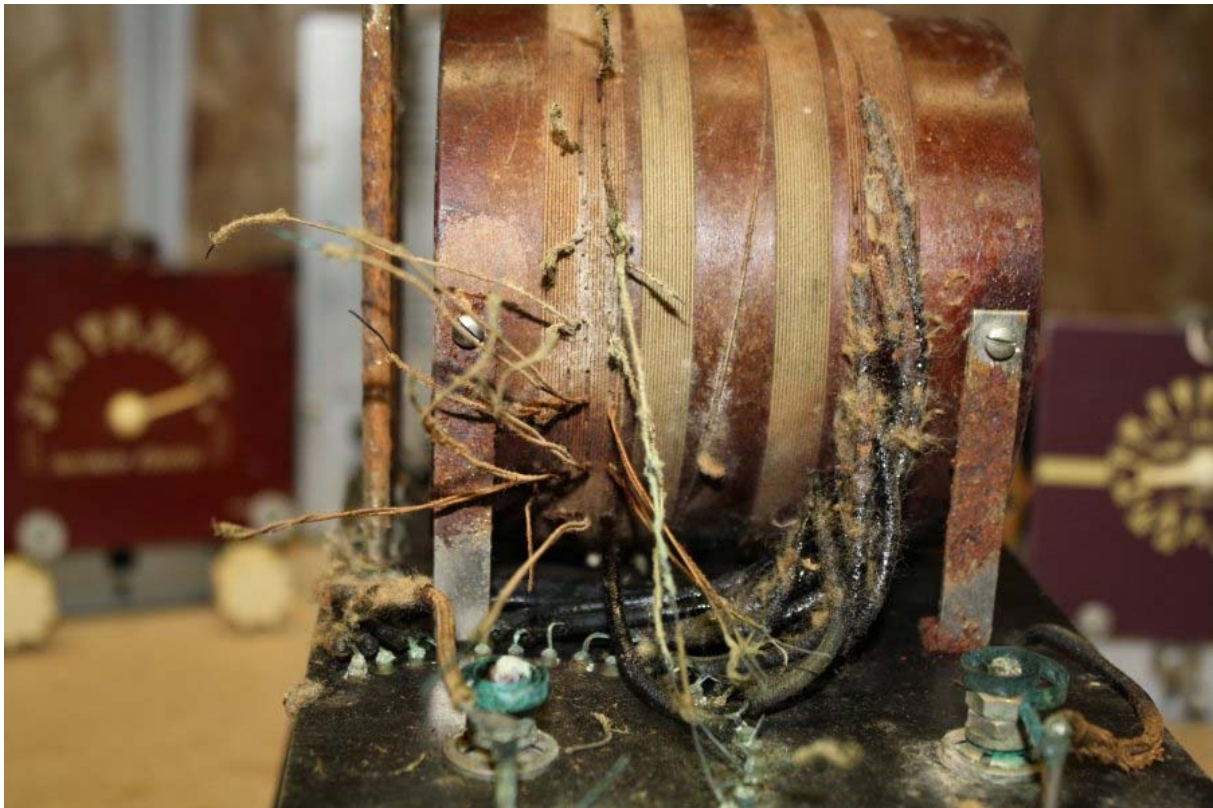
The fixed portion of the variometer has two coils separated in four windings (see picture below). The two center windings are the antenna coil and did not suffer from the mice.

The two outer windings are for regeneration and have 31 taps that go to the 31 position switch. Only 7 of those were still connected to the switch. The rest was eaten by the acid of the mice urine. Furthermore, the mice ate the insulation on most of the wiring because it was covered in lacquer and, apparently, it tastes good for them (I never tried).

So, my first challenge was to disassemble the variometer without damaging it further. After clean-up, I used what was left of the taps to solder new wires to go to the switch (see next page).

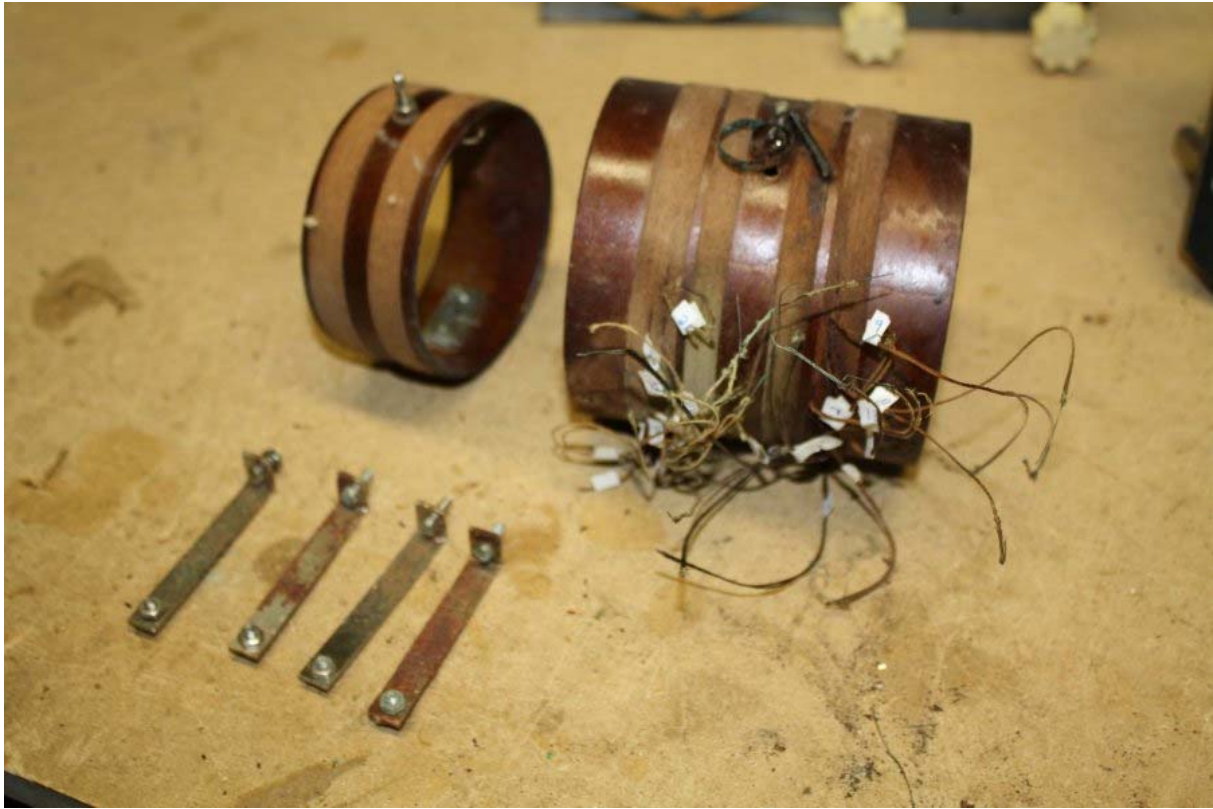
Variometer disassembled and cleaned.

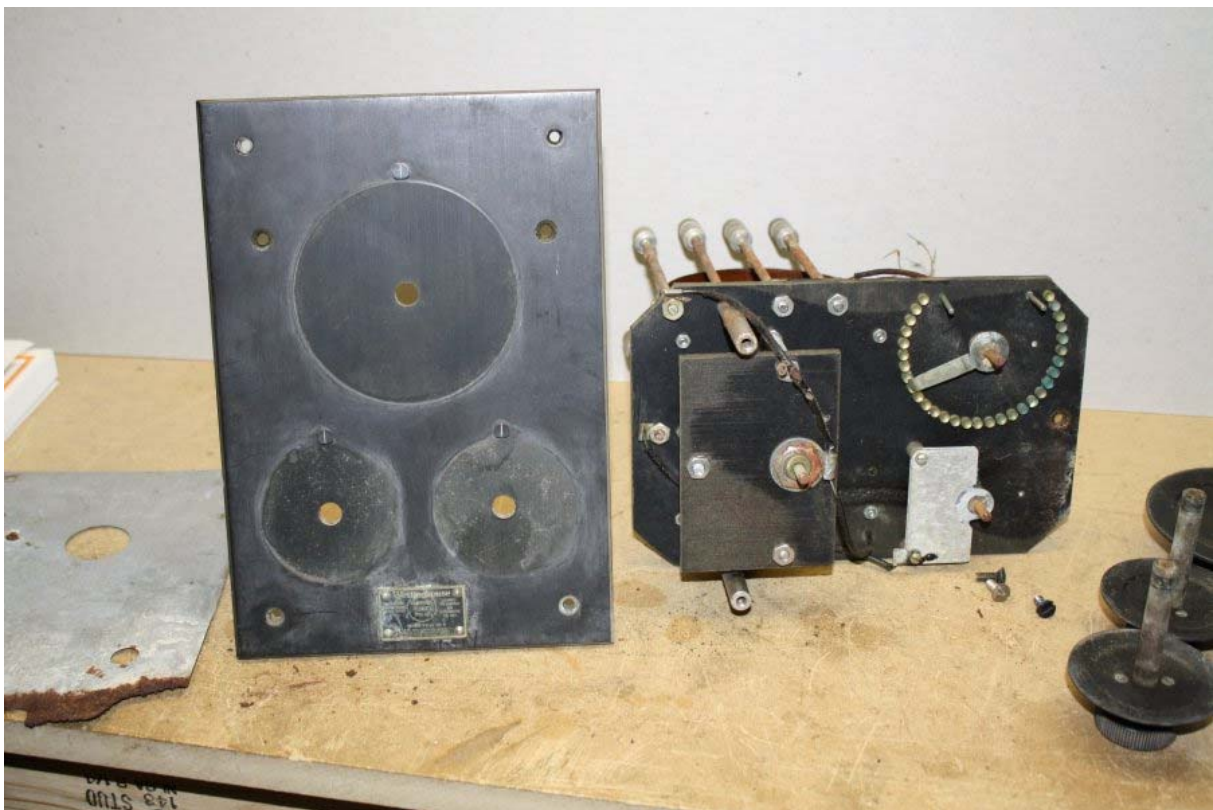
Controls, faceplate and shield removed.

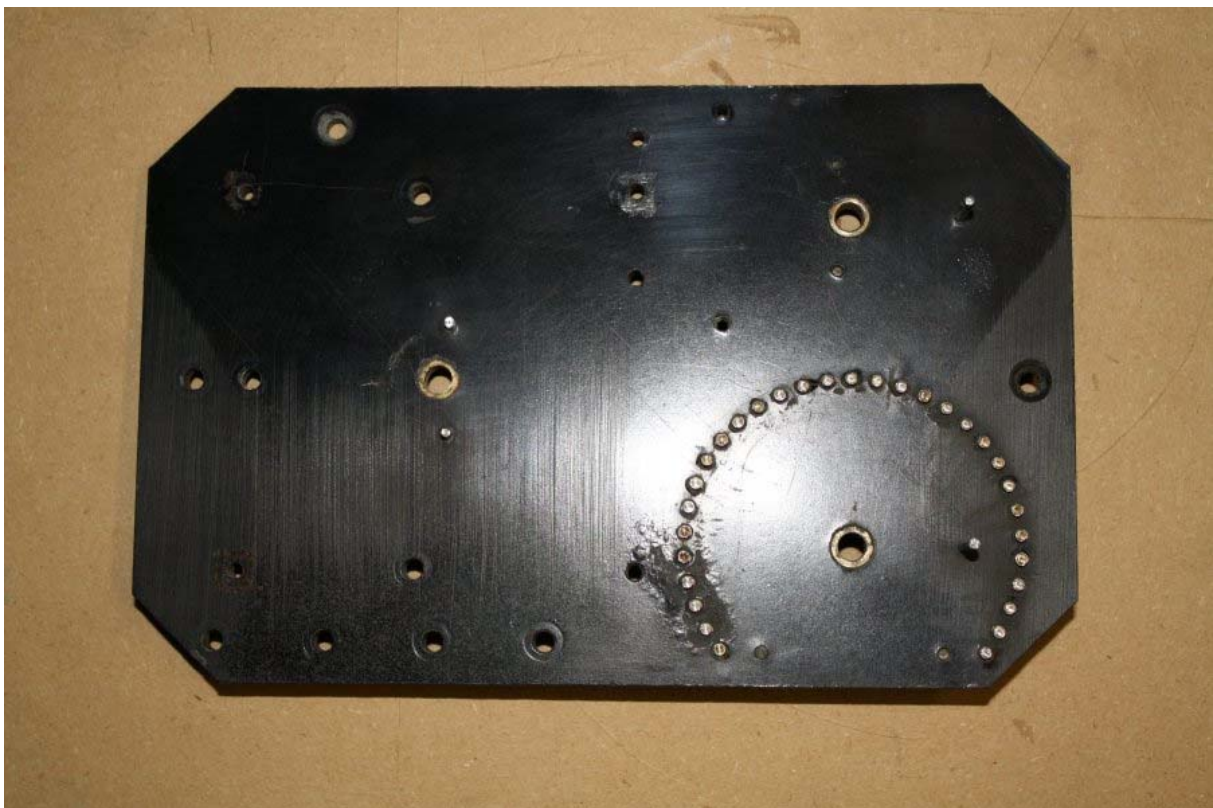
Main board stripped of all parts and cleaned.

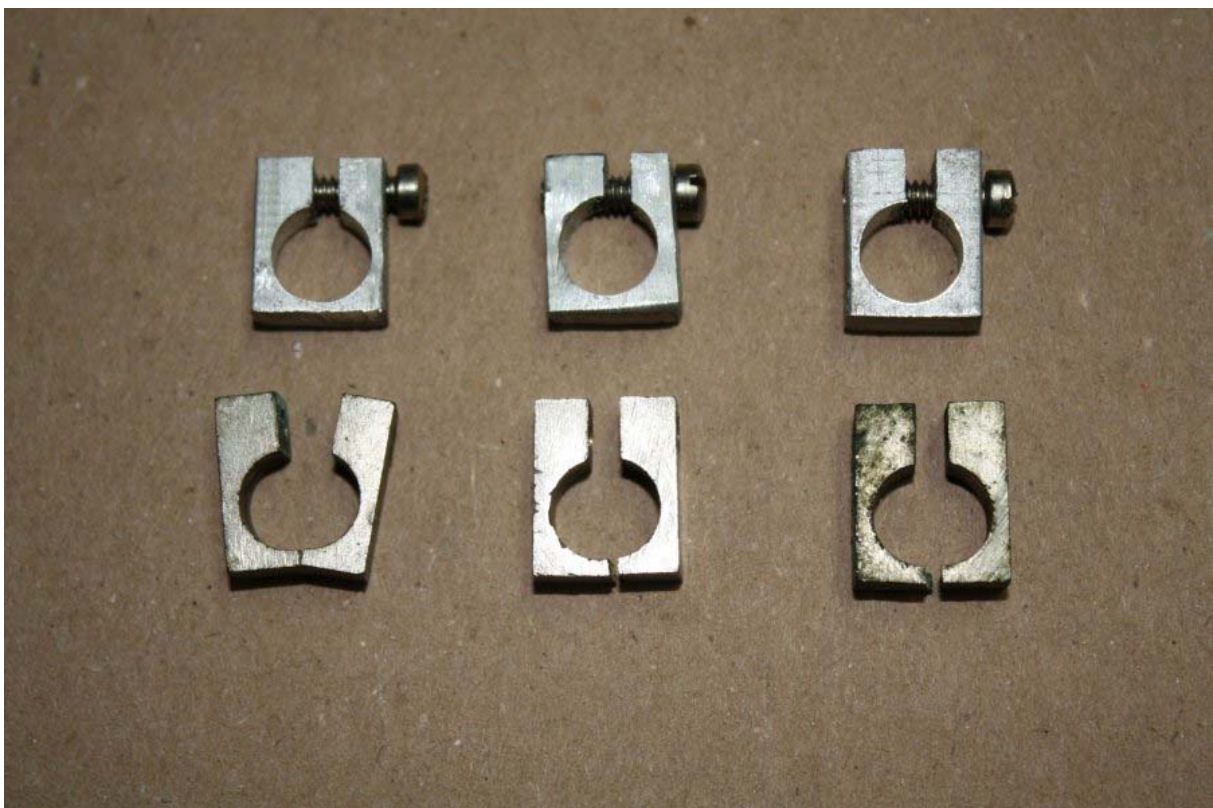
The three collars holding the knob's shafts were cracked.

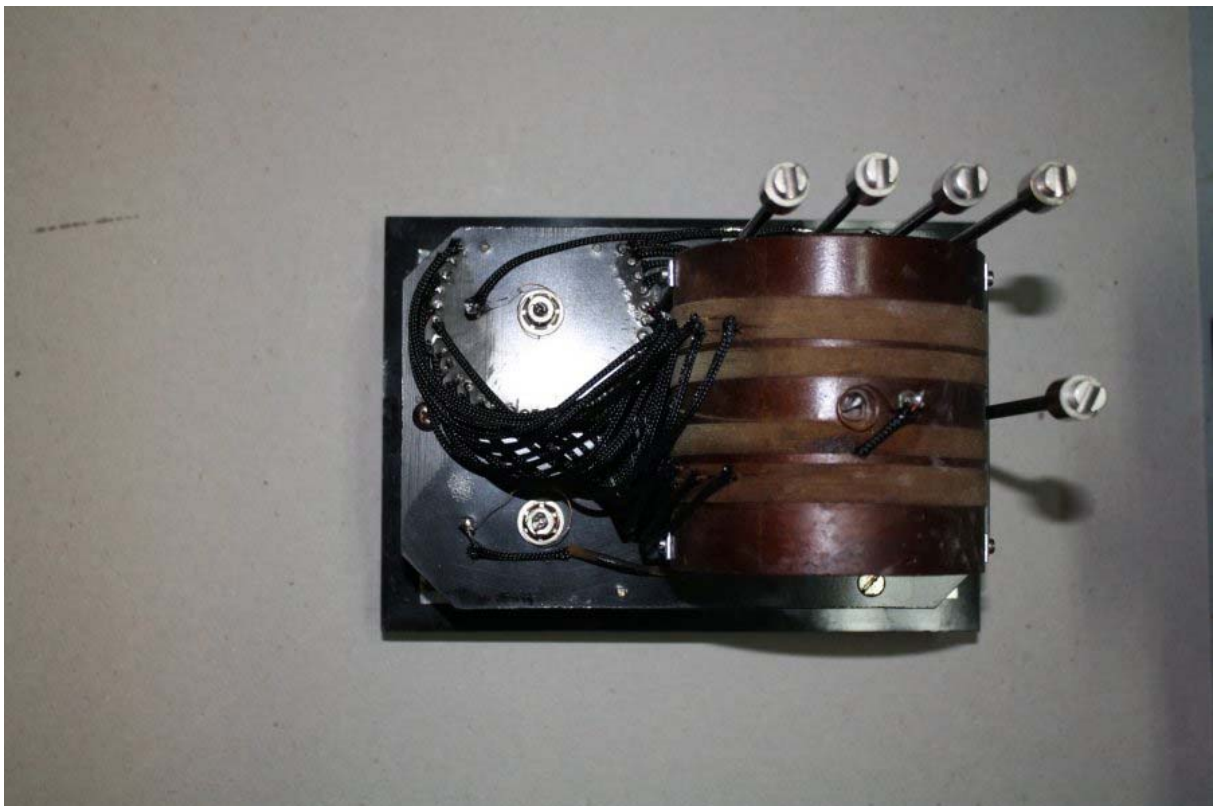
Another view.

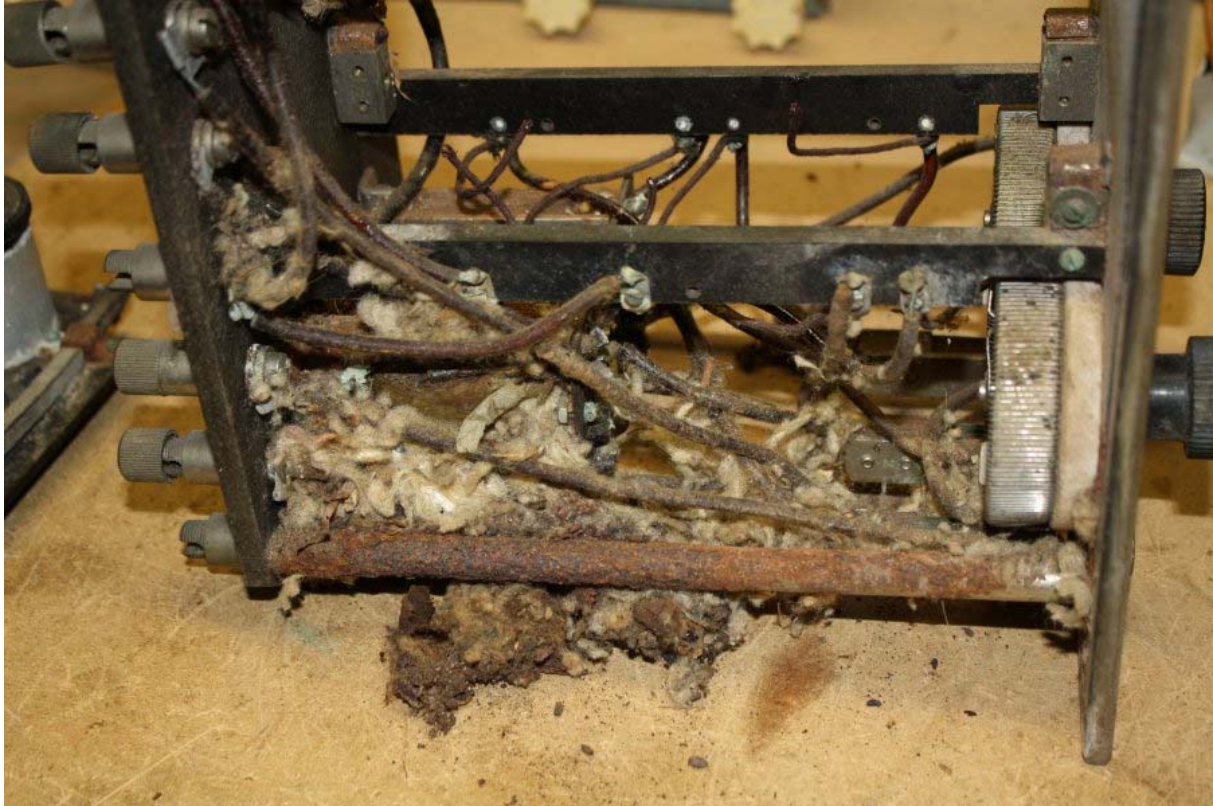
A view from the side.

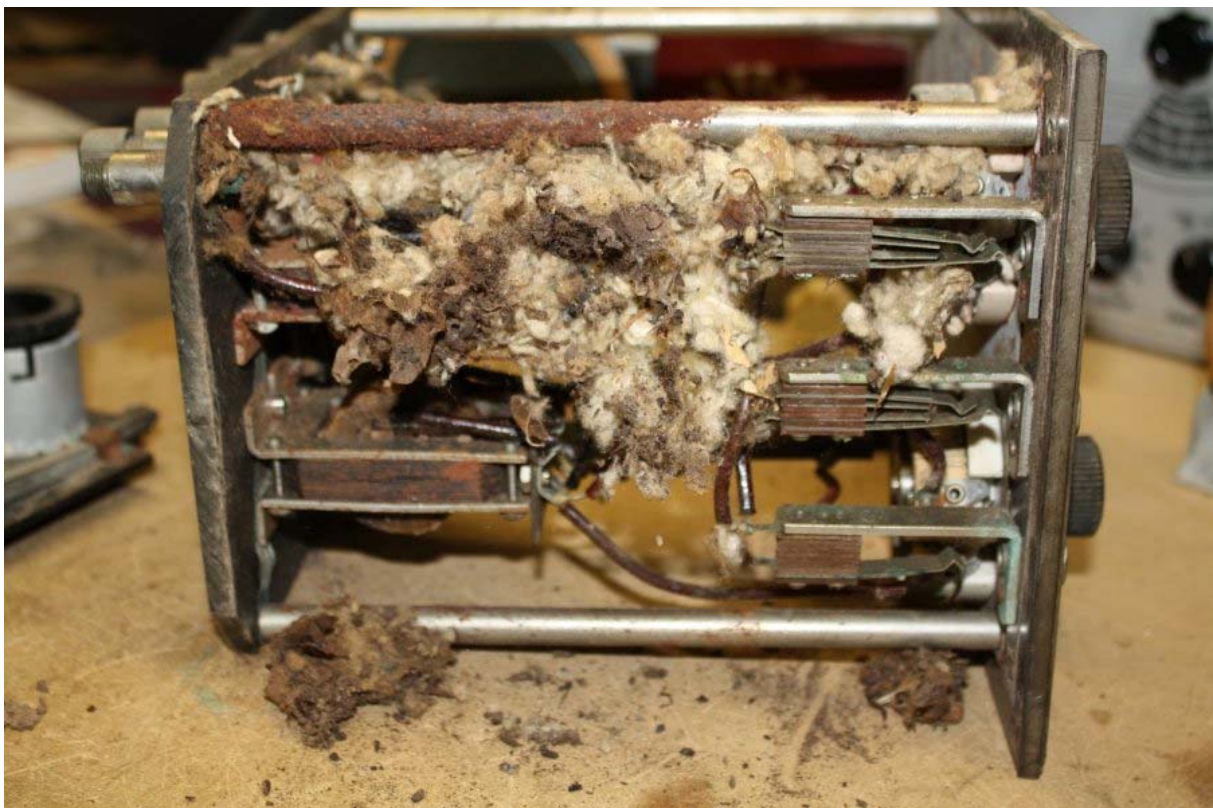
A more inviting view from the bottom.

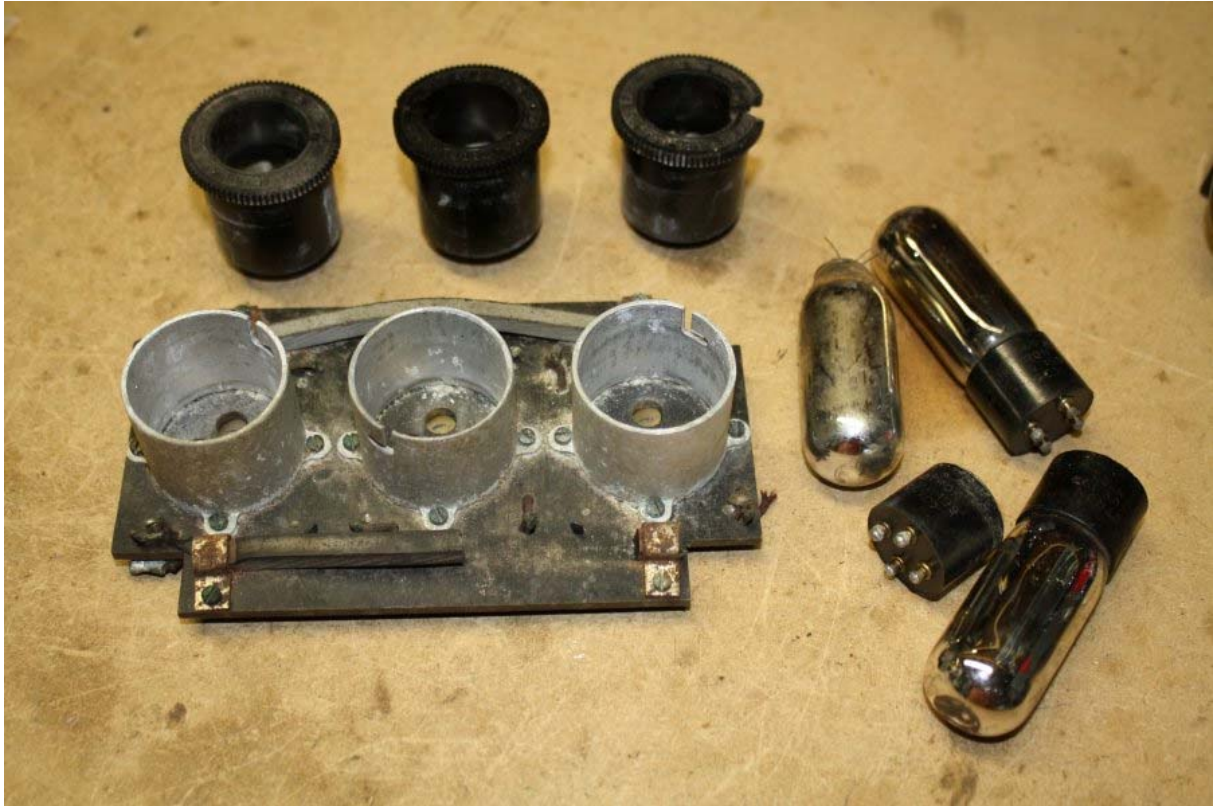
The rubber bands holding the plate were dry and broken and the fine flexible wires that linked the sockets to the rest of the module were all gone. Again, such a simple schematic but so much wire in that module, a very interesting puzzle.

Sockets, dried rubber bands, tubes and adapters.

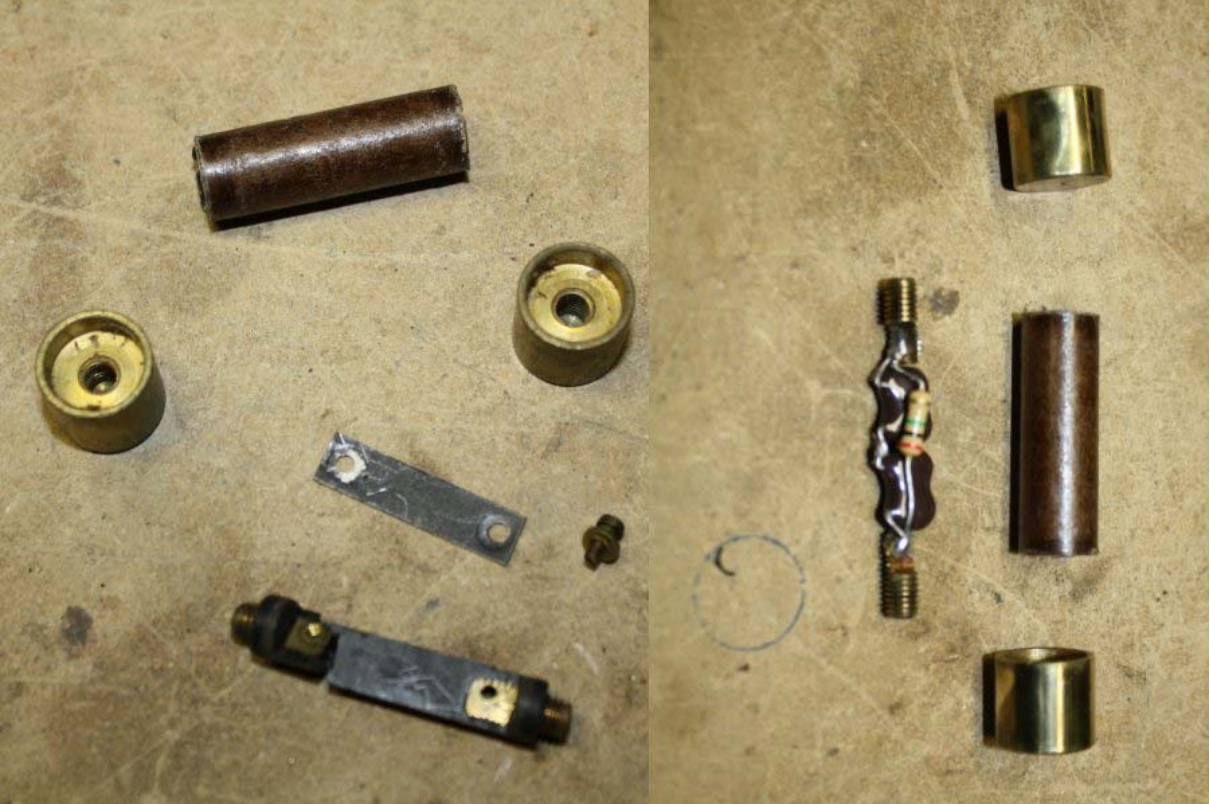
Grid leak detection cartridge was open. Easy to fix for once.

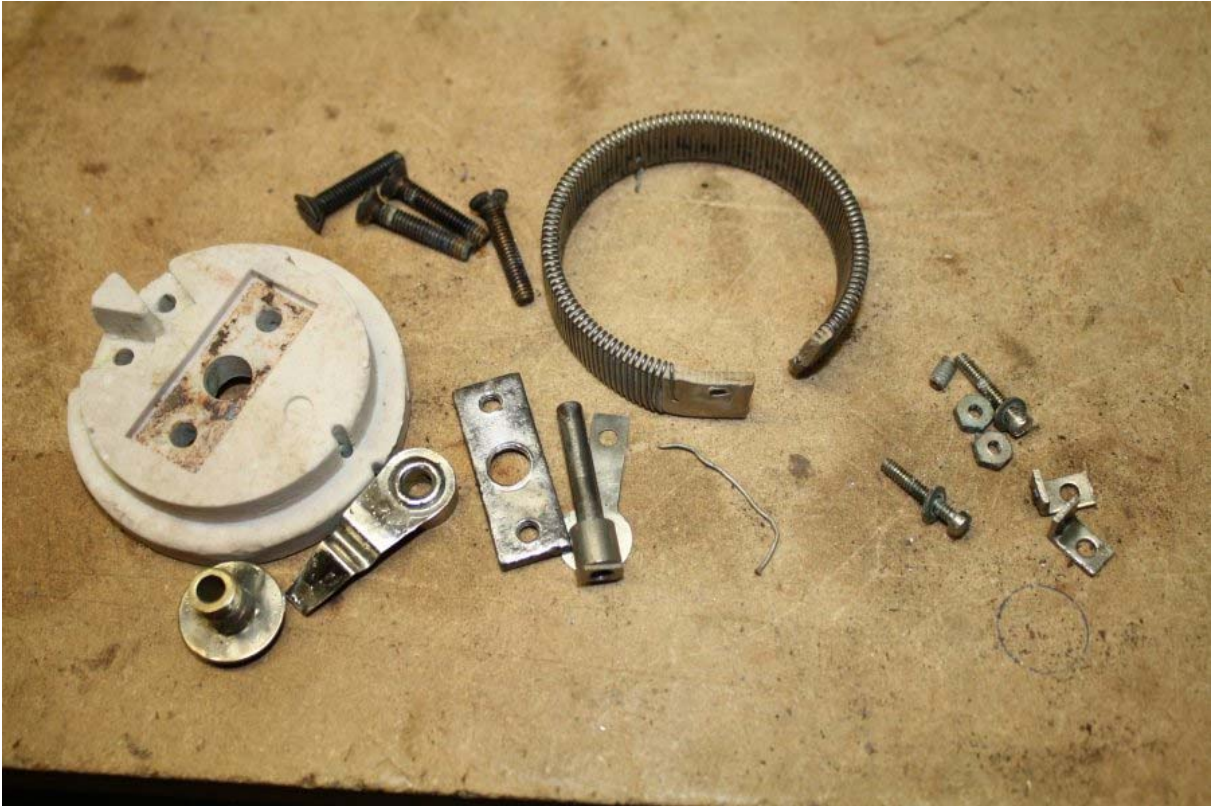
Rheostat dismantled for cleaning.

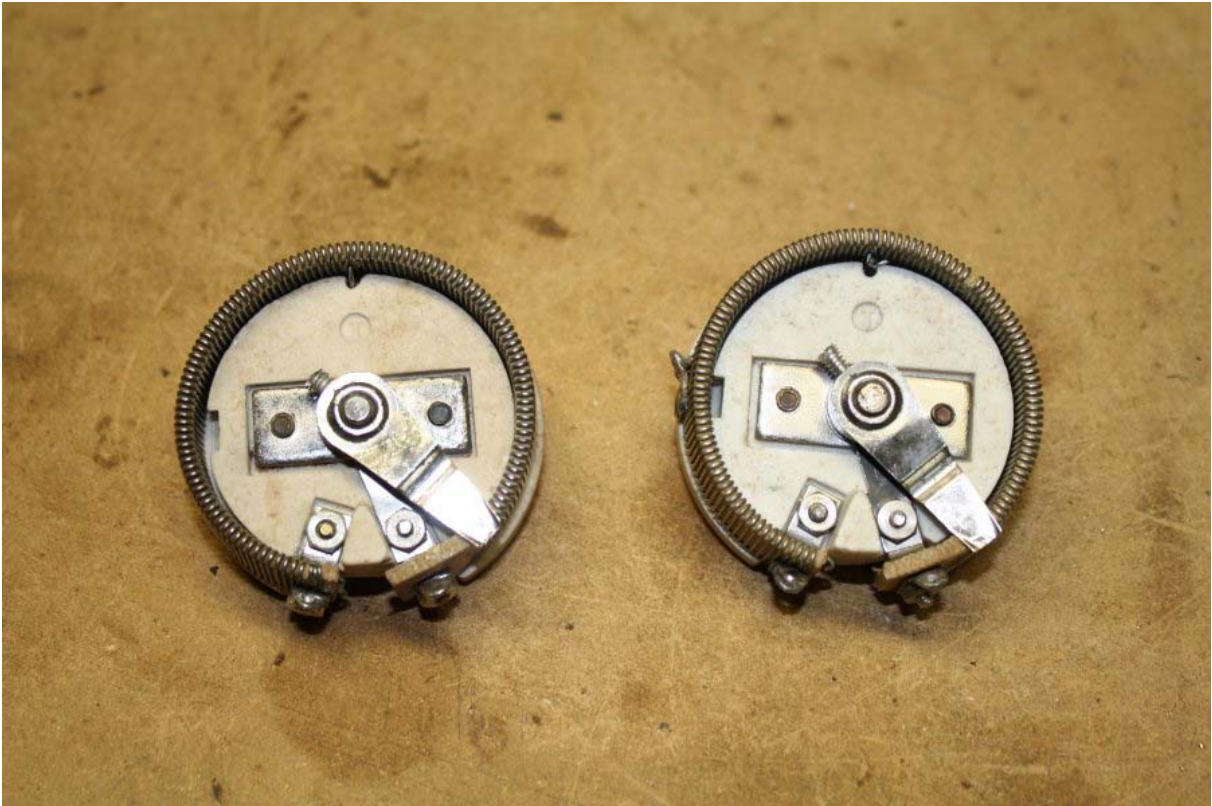
The amplifier rheostat had two breaks in the winding. Now fixed.

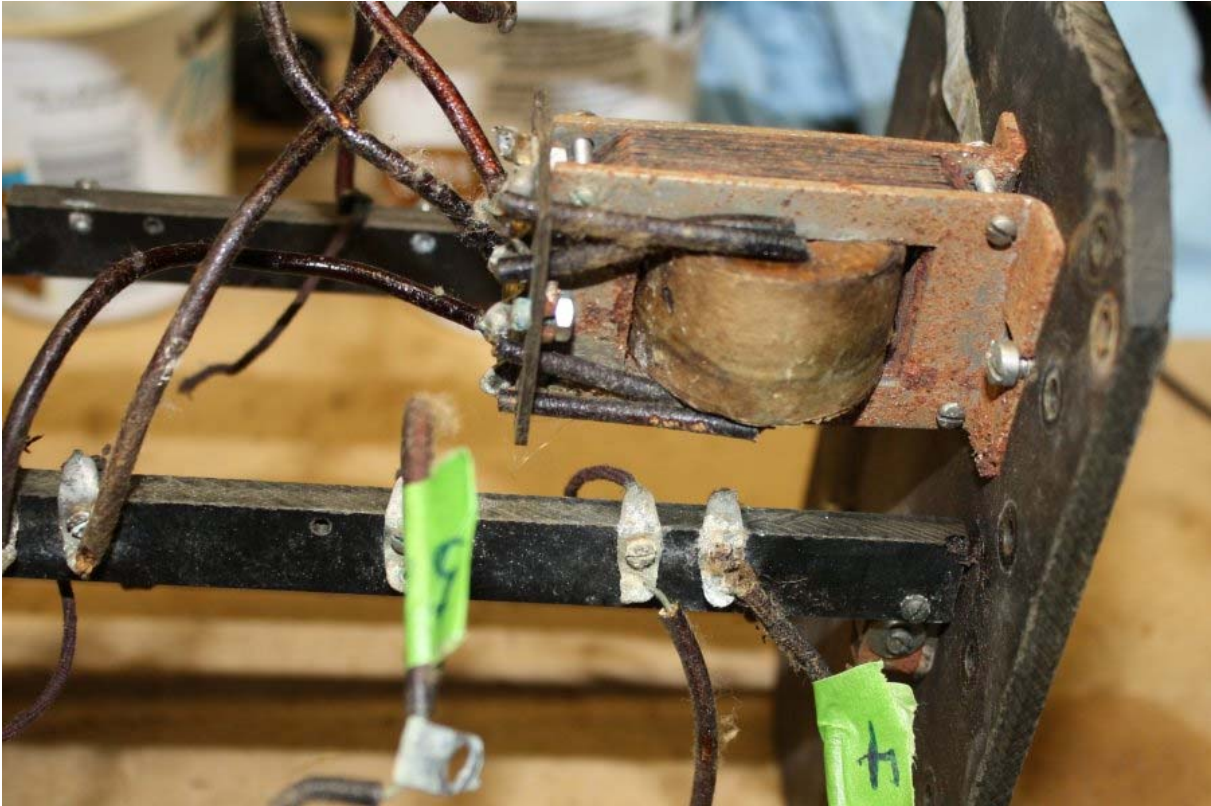
I expected a miracle but was rewarded with both transformers open, primary and secondary. I am not equiped for rewinding transformers and they use around 15 000 turns of number 42 wire wich is just a tad smaller than one of my hair.

One of the two transformers.

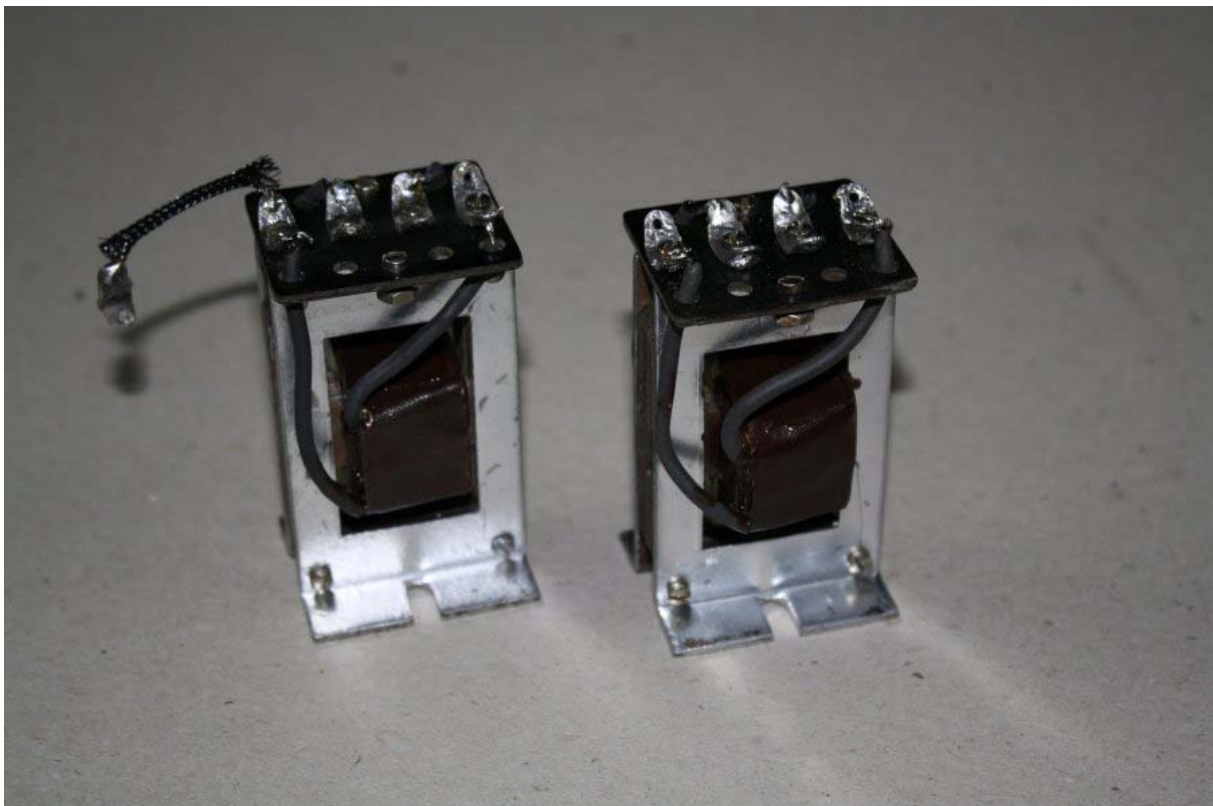
Both transformers rebuilt with new Hammond coils.

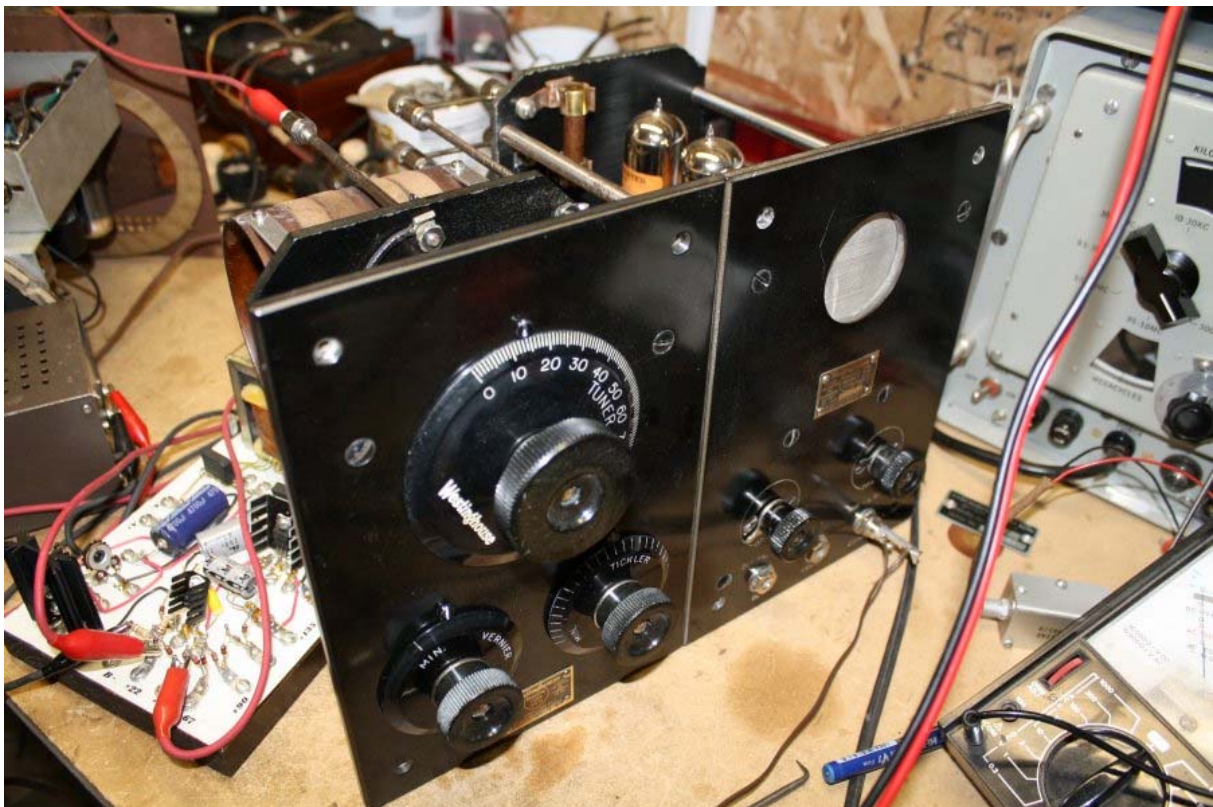
After mating the two modules I made some testing using the Arbe II power supply. I used the following values for the tubes, 5 volts for the filaments, 22.5 volts on the detector tube plate and 45 volts on the amplifier tubes plate. I was initially deceived by the results. Very noisy reception and unacceptable hum. I determined that the hum was coming through the filaments. This were I swichted to the fixed 5 volts power supply and that cured the hum problem. Next I tried to use two 9 volts batteries for the detector plate to remove the Arbe II power supply from the antenna circuit (through regeneration). Not much of a change but I realized I had miswired the batteries, connecting them to the amplifier plates instead of the detector plate. I then remembered that when I bought the radio there was a jumper between the B+ of the detector and the B+ of the amplifier, so they were working at the same voltage. I put back the jumper in place and used only the two 9 volts batteries. I got fairly good reception with acceptable volume in the speaker and a less noise. After further testing I determined that 27 volts was probably the best figure.
