Restoration of a
1921
Westinghouse
model RC

by
Jean Marcotte
for

SQCRA

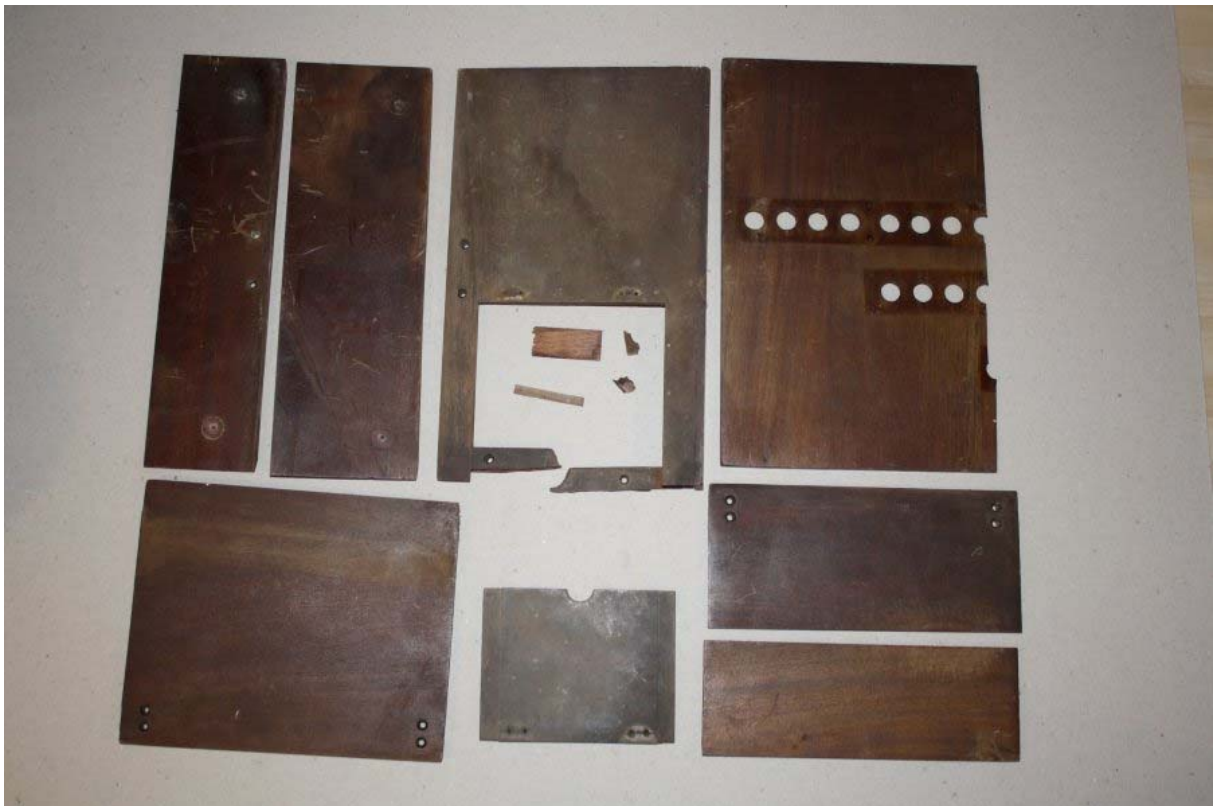
I took the casing apart. A piece of the back remained glued to the top panel. I started with Mr. Jinks' damage. The scratches were deep and the crack was wide. The wood panels are made of mahogany and are 5 mm thick. The scratches were over 1 mm deep. I had three options. Replacing the panel with new wood, filling the scratches and gluing veneer or thinning the original panel by sanding it. I chose the third option because it is the easiest, keeps the look of the original panel and I can always revert to option two or one if I am not satisfied. Another benefit was collecting the dust from the belt sander and mix it with glue to create a filler for the cracks. The panel ended a little less than 4 mm and was still sturdy enough. The broken panels were glued back together and warping controlled in the process with numerous clamps. The enlarged hole was filled with my homemade filler.

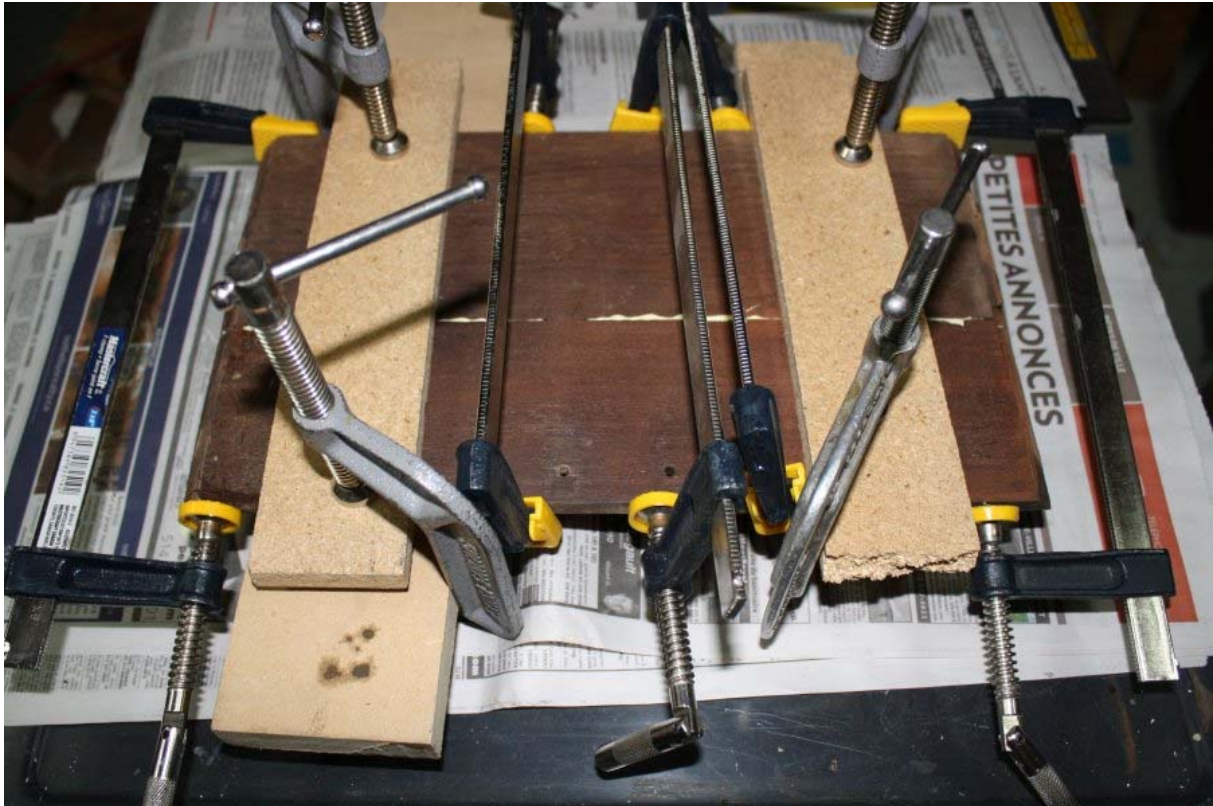
Straightening and gluing back the panels.

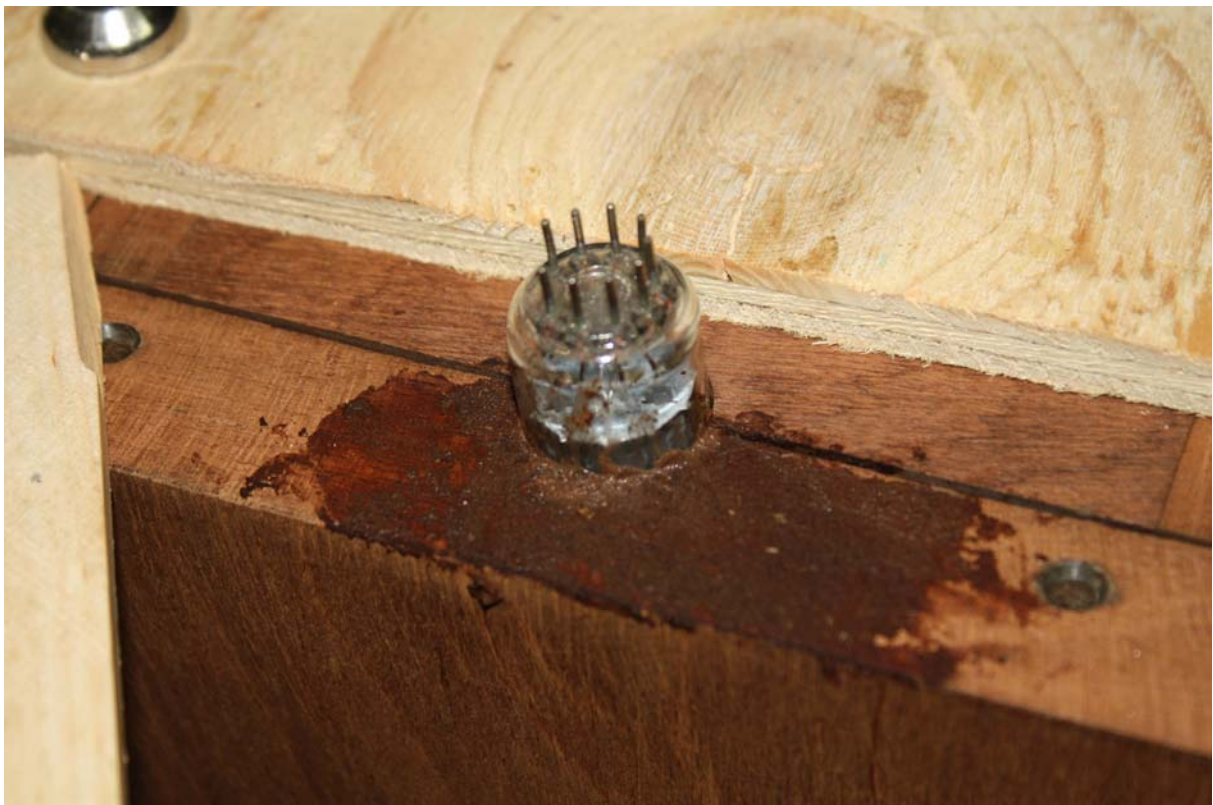
This is an "unconventional" use of a 12AX7 (filament open).

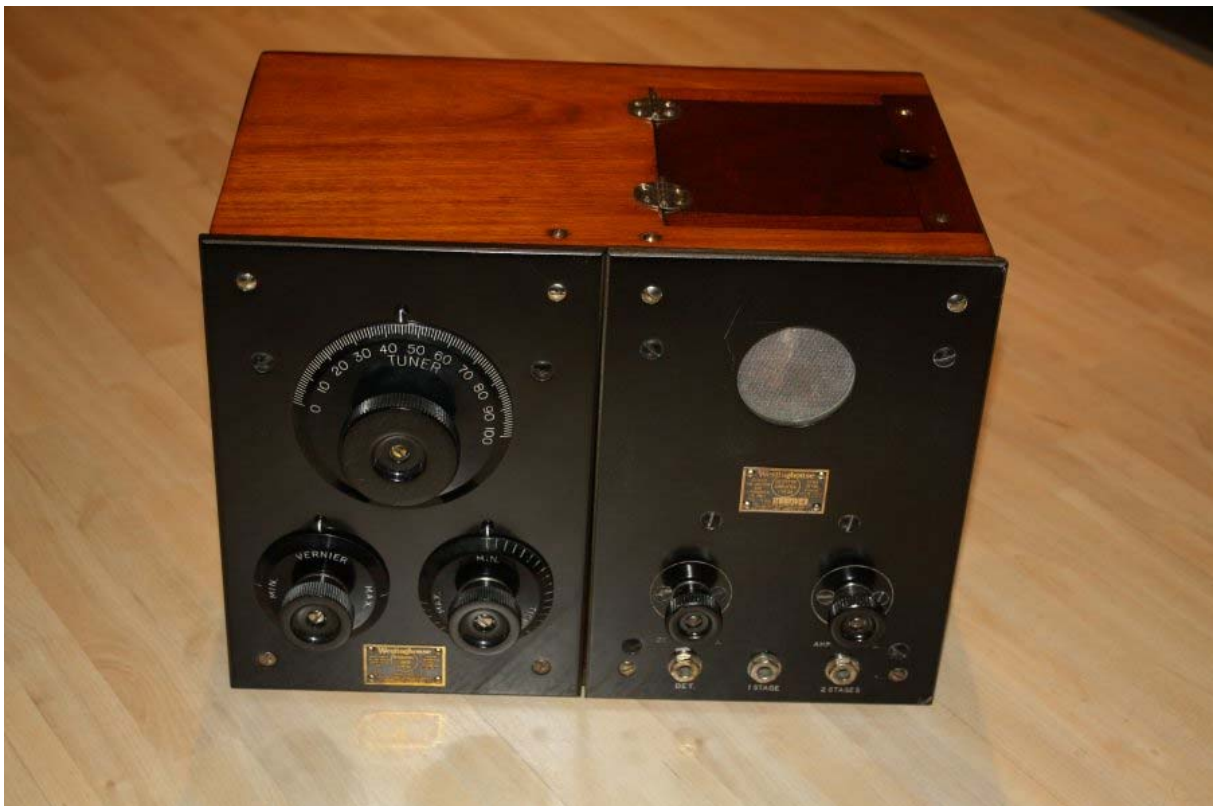
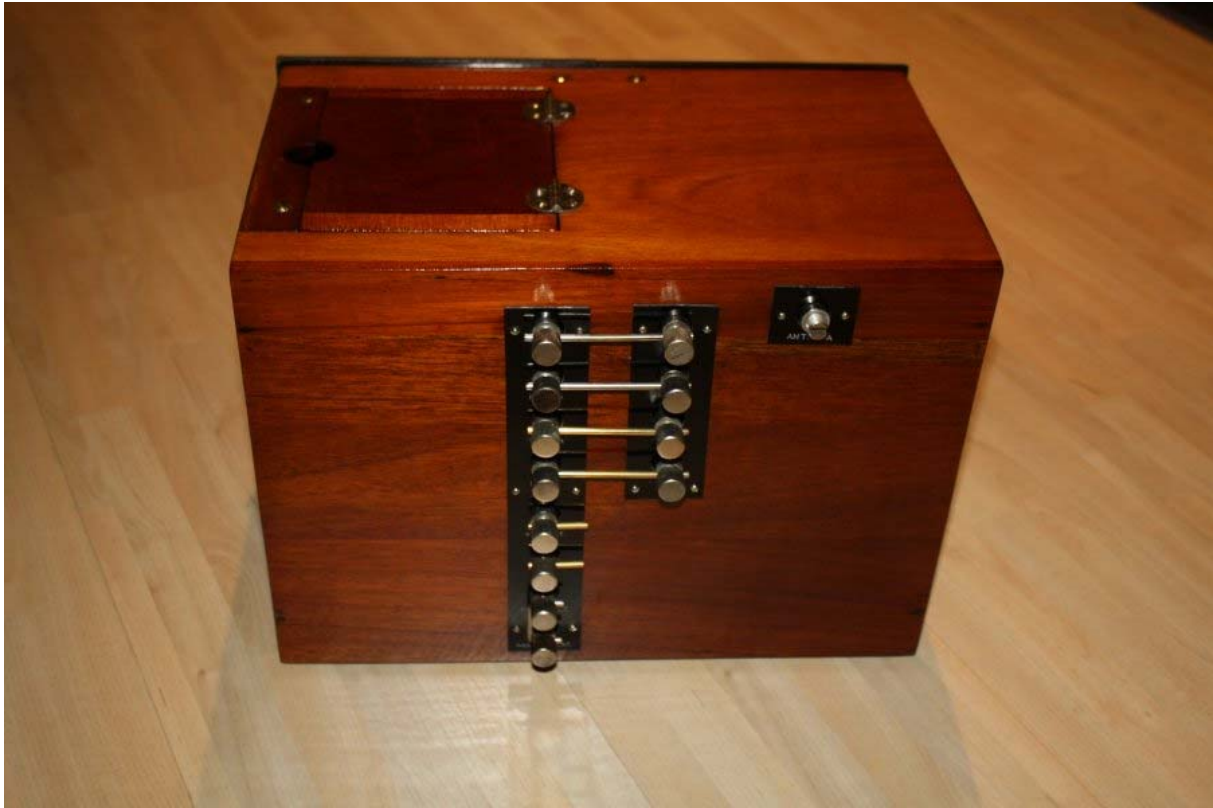
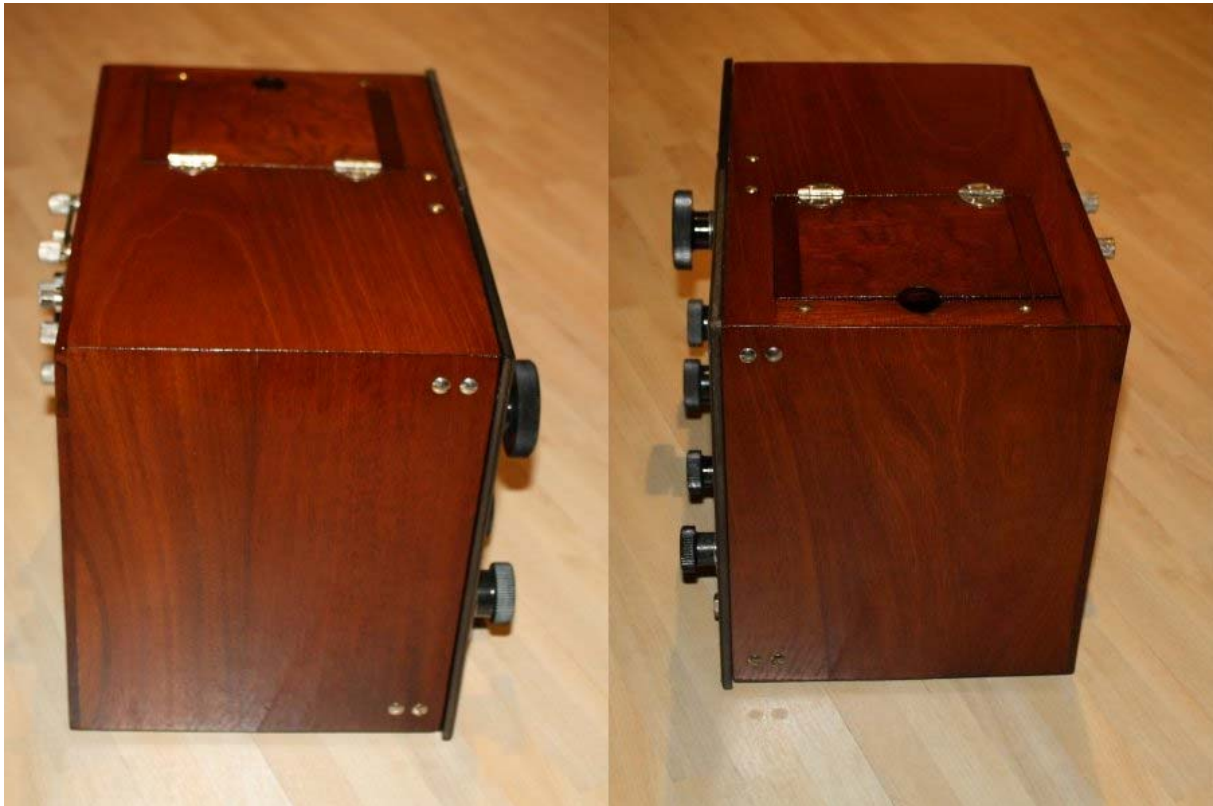
The final product.

Reassembling the cabinet was straightforward. All parts fitted easily with no more warping on any of the panels. After a final sanding, I applied a few coats of shellac with a brush as it was the finish used in those days. Notice the difference in shade of the tube door. It varies according to the angle from which we look at the radio. This difference can be seen in the pictures taken before the restoration but less obvious because of the amount of dirt on the top. So I did not try to correct this.

A few pictures of the final result.
